MEMORANDUM REPORT NO. 2098

ANALYSIS OF COMBAT DAMAGE ON CH-53A AND HH-53B
HELICOPTERS IN SOUTHEAST ASIA
(1967 THROUGH JUNE 1969) (U)

Walter S. Thompson
Raymond E. Wheeler

June 1971

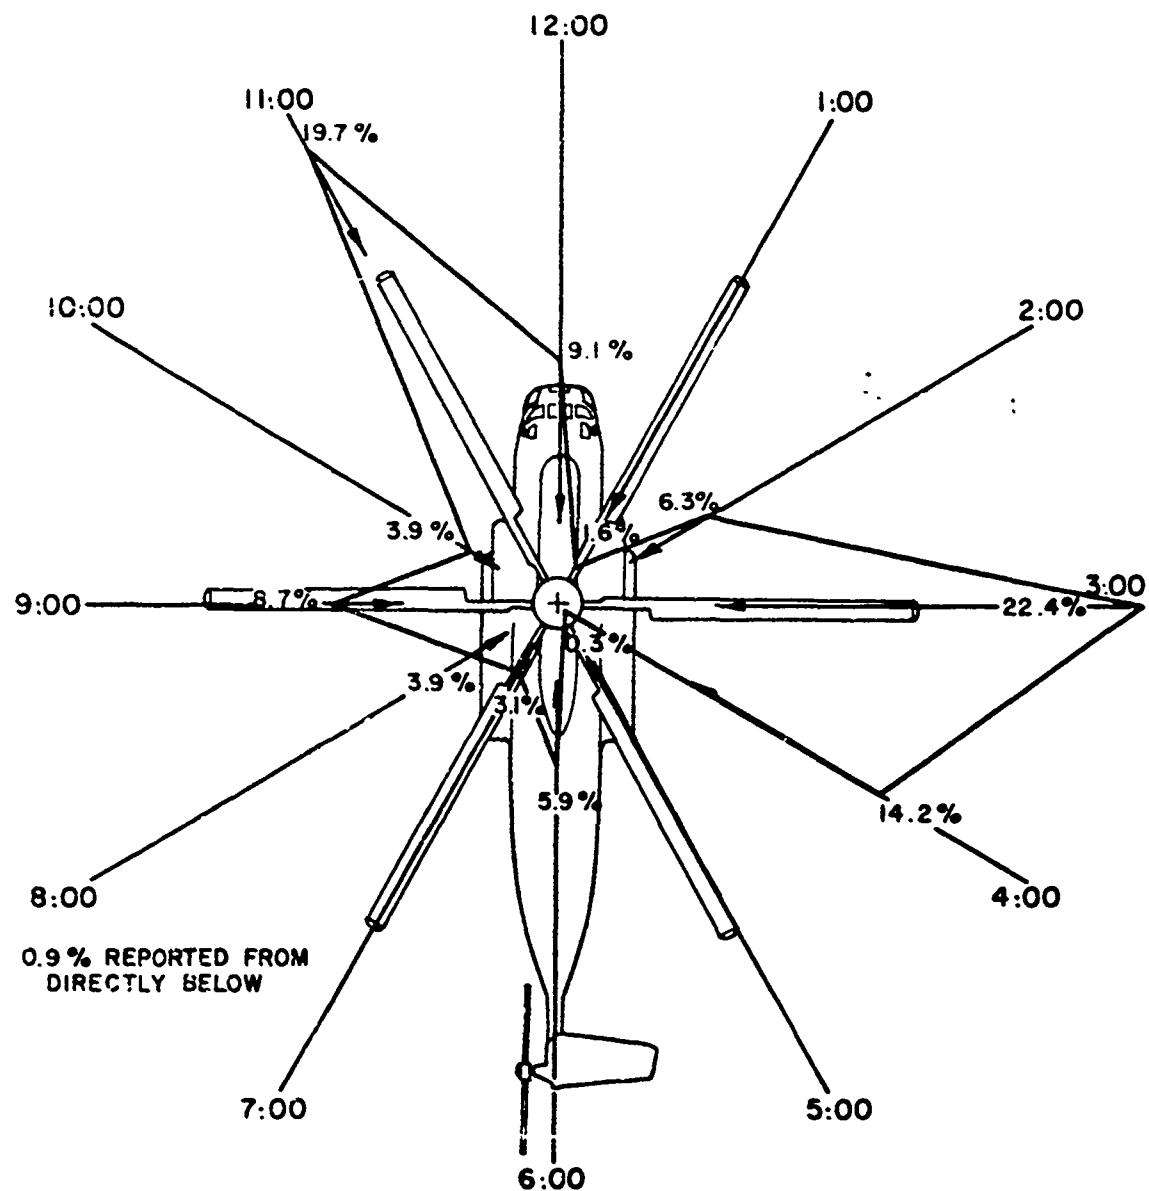
Direction-of-fire data were reported for about one-third of the individual hits reported; these data are presented in Table D-VIII. The general patterns of direction-of-fire data for caliber .30 weapons and for caliber .50 weapons are reasonably consistent with that for total hits, which is plotted in an azimuth presentation in Figure 3. By quadrant, the right side of this helicopter received 42.9 percent of the total hits and the front received 30.4 percent; the left side received 16.5 percent and the rear received only 9.3 percent. The relatively high proportion of hits reported at 3, 4, and 11 o'clock positions are not the results of one or several cases involving a great many hits, but were accumulated through numerous cases. The reasons for this predominantly right-side and frontal distribution are not apparent within the scope of the data reported. It could be suggested, however, that the location of the pilot and personnel door on the right side possibly affects the manner in which all models are maneuvered in the vicinity of the landing zone, a frequent source of ground fire.

NOTE: ONLY HITS WITH DIRECTION REPORTED ARE SHOWN. HITS RECEIVED WHILE ON GROUND NOT INCLUDED. DISTRIBUTION IS FOR 30 % OF TOTAL HITS, 32.5 % OF HITS WHILE AIRBORNE.

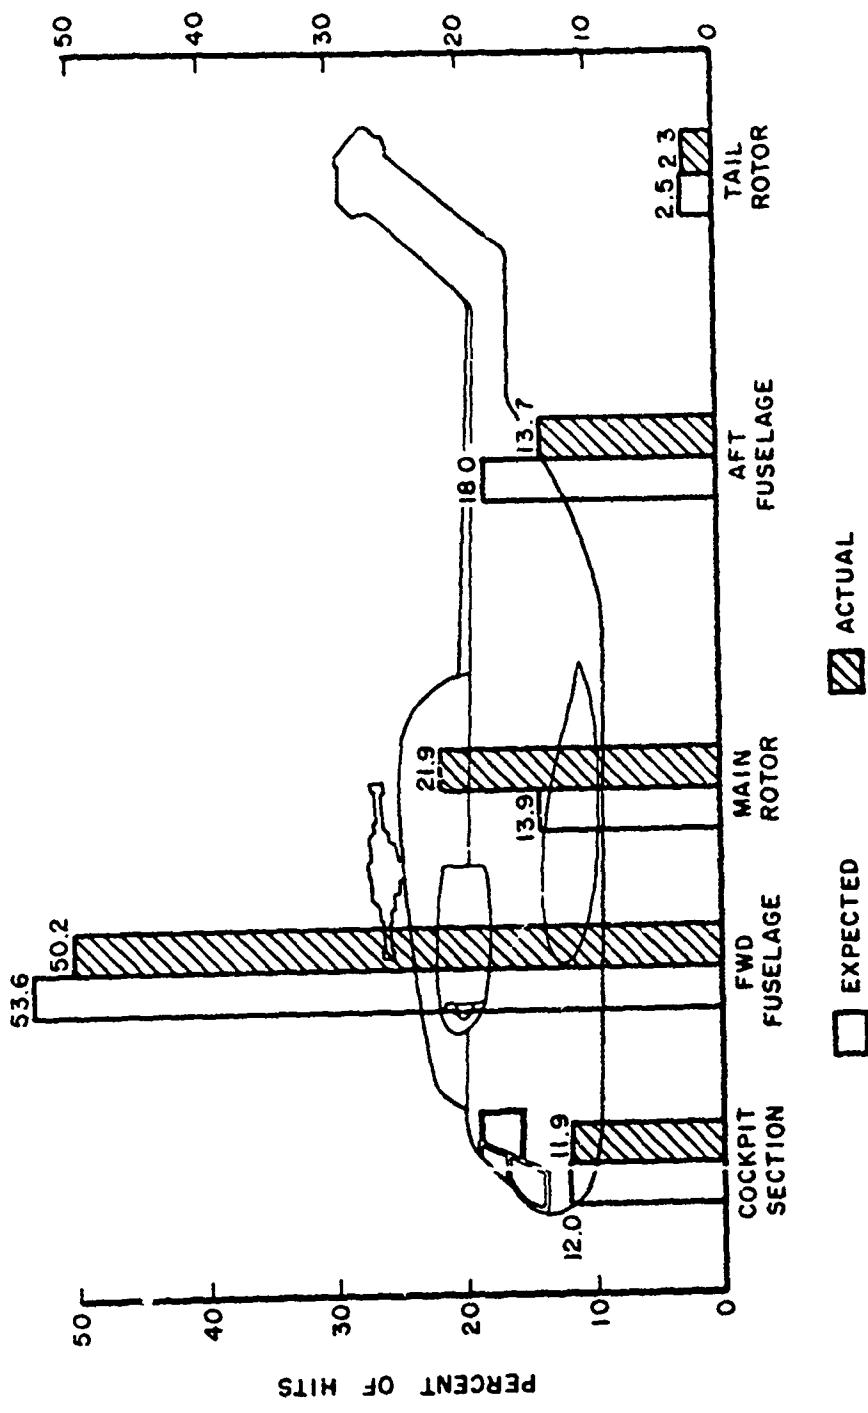
Figure 4 (C). Percent of Total Hits on Major CH/HH-53 Compartments (U).

Distribution of hits by aircraft section or compartment is presented in Table D-IX and in Figure 4. The actual distribution observed for the various threats is compared to the predicted distribution, assuming a uniform pattern of hits distributed by presented area. This hypothesis appears correct since reasonably close correlation between expected and actual distribution is exhibited. Similar correlations were obtained for the individual weapon types.

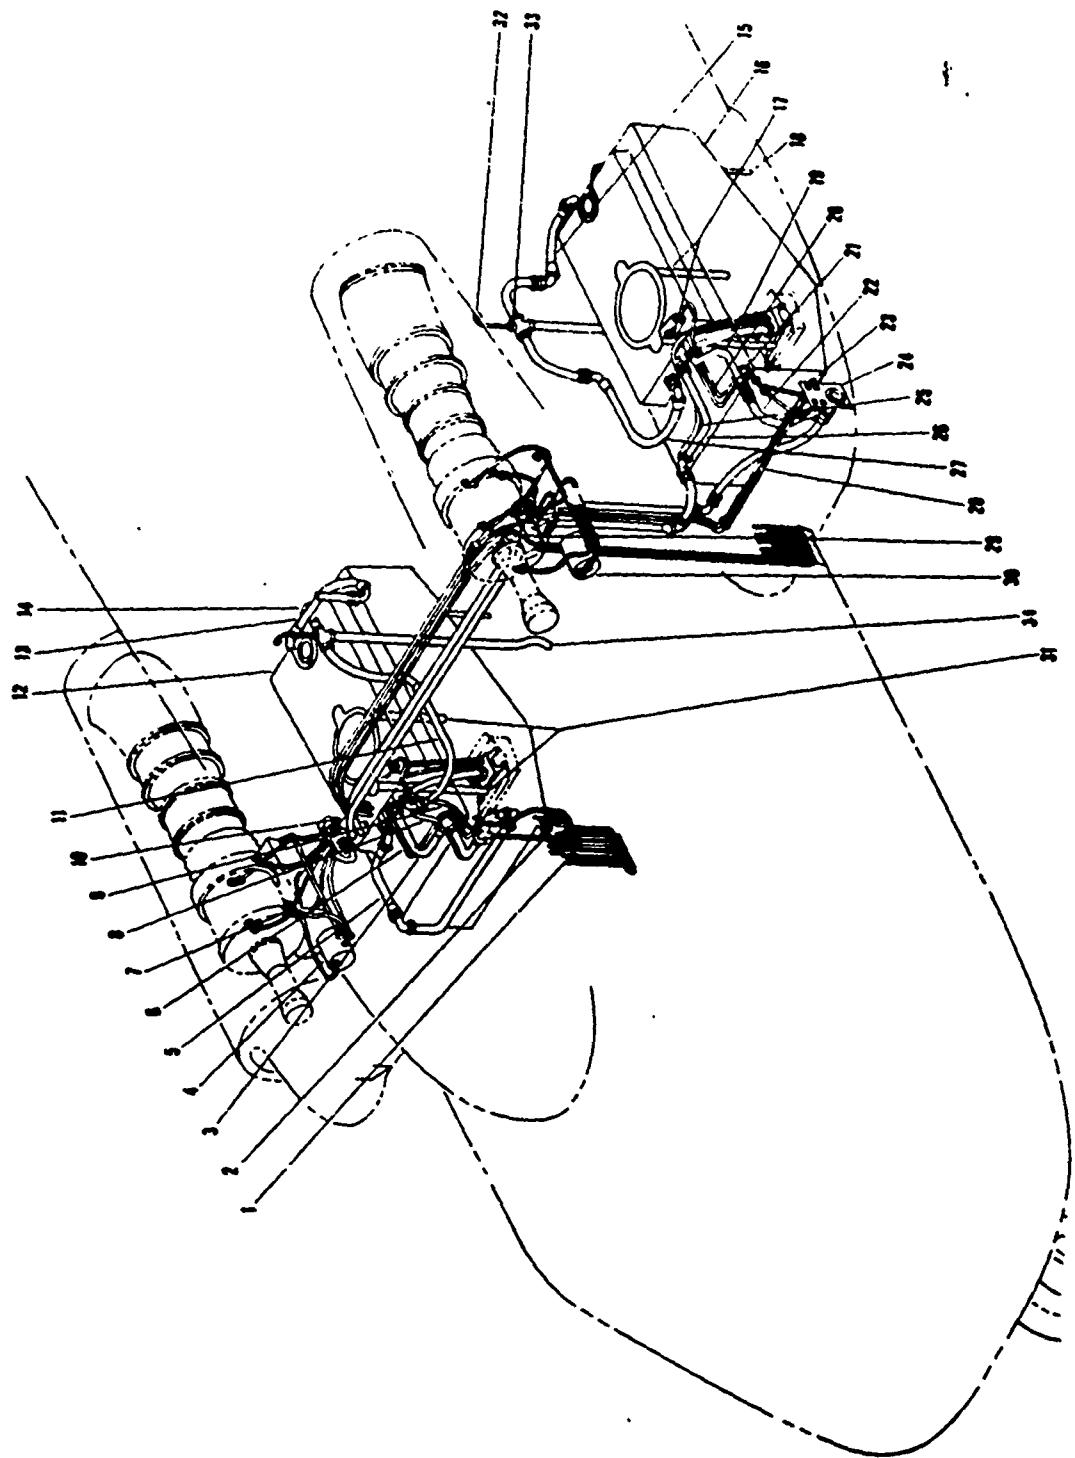
Figure 5. (U) Fuel System (U)

A total of 19 hits (all caliber .30) were taken in the self-sealing main fuel cells, occurring in a total of 16 cases. Details regarding resultant leakage were generally lacking; however, the helicopters continued performing their missions in 14 of the cases, including one case involving two such hits. One case (single hit - Case 80099) resulted in a mission abort; another (Case 80008) involved three hits on the main fuel cells and three additional hits on the drop tanks (the aircraft was a USAF HH-53B) resulting in a mission abort when all fuel was lost from both drop tanks. The main cells, however, lost very little if any fuel.

In addition to the above three hits on drop tanks in Case 80008, one more hit on a drop tank was reported. It too caused a mission abort (Case 70101) when part of the tank fuel load was lost. It is interesting to note that Case 70101 involved additional fuel system damage in the form of a pierced fuel supply line for one engine which was operating under suction conditions and did not leak significantly*.

The second incidence of damage to a fuel supply line was reported in Case 90020 and led to a forced landing (after flying on a single-engine power to a secure area) after a caliber .30 bullet passed through the line and caused the number one engine to fail through fuel starvation.

Damages to a fuel transfer line (probably empty), a fuel vent line (obviously empty of liquid), a fuel line of unspecified function, and a fuel heater line were incurred without adverse affect. The latter was reported to be bent, but not punctured.

Three cases of damage to unspecified fuel system components, including one by a caliber .50 bullet, were reported as leading to forced landings. In one case, the fuel indicator "went to zero," but no further details are available on any of the three incidents.

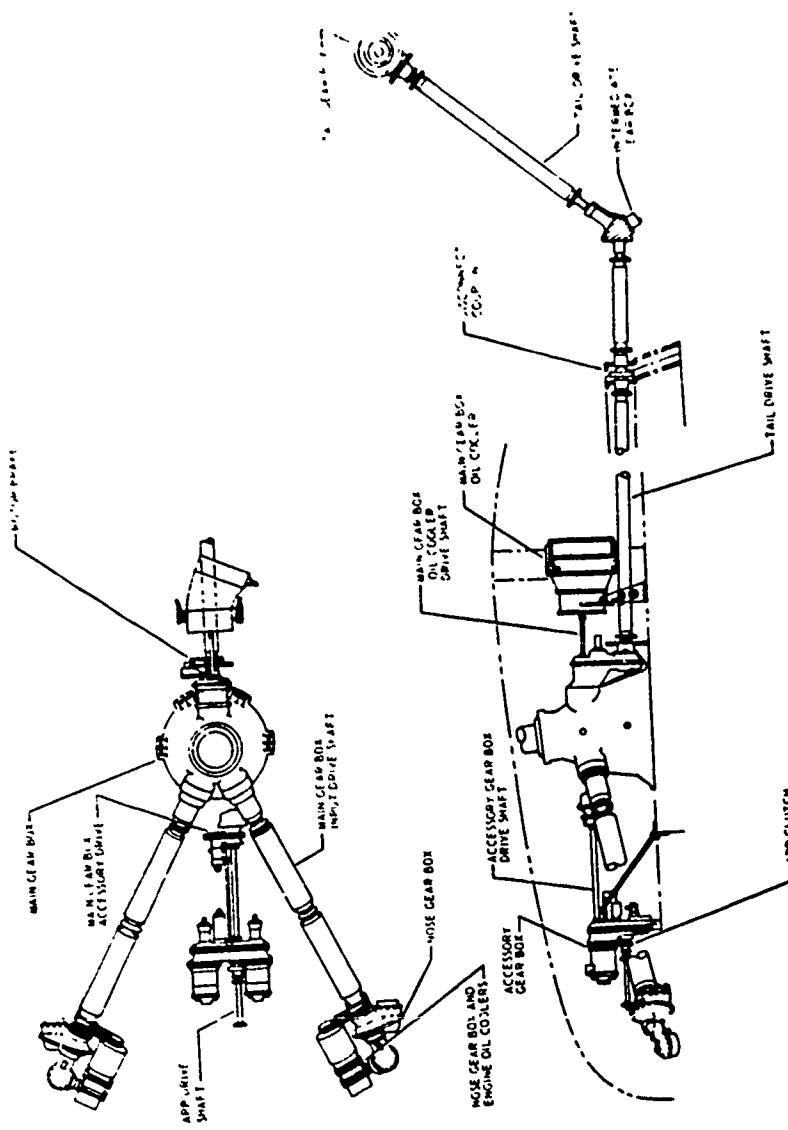
Figure 7. (U) Transmission Systems (U)

There were 12 reported cases with 13 hits on the transmission system. Five combat damage reports cited a total of six hits on the main transmission. In Case 80044 a caliber .30 bullet penetrated the transmission and caused a small oil leak; no adverse reaction resulted. In Case 80164 a caliber .50 bullet struck the transmission; damage was not specified, but the aircraft continued on its mission. In Case 80155 a caliber .30 bullet entered the bottom of the aircraft and struck the bottom of the transmission, apparently failing to cause an oil leak or other significant damage; this aircraft also continued on its mission. In Case 80101 a caliber .30 bullet punctured the transmission casing and caused a small oil leak; the aircraft was landed and a patch was improvised, whereupon the mission was resumed without further difficulty. Two hits were registered by fragments from an AAA projectile in Case 80045 and led to a mission abort; one fragment hit a transmission mount and another gouged the casing after striking a second-stage hydraulic pilot valve body. The transmission damage was

minor but the mission was aborted due to hydraulic system damage and failure.

Caliber .30 bullets struck the tail rotor drive shaft on four occasions without causing critical damage. In each case the aircraft continued on its mission. One report cited complete penetration of the shaft, another described the damage as a dent one-quarter inch deep at station 719. Damage was not described in the other two cases.

Caliber .30 bullets struck the transmission input shafts in two cases, causing similar damage. In each case the bullet hit the drive shaft coupling and shattered. In Case 70215, the impact caused two 1/4-inch cracks in the transmission and a bullet fragment made a small cut in a first-stage hydraulic line; this aircraft continued on its mission. In Case 70237 the bullet fragments severed a first-stage hydraulic line, causing pressure loss which led to a precautionary landing.

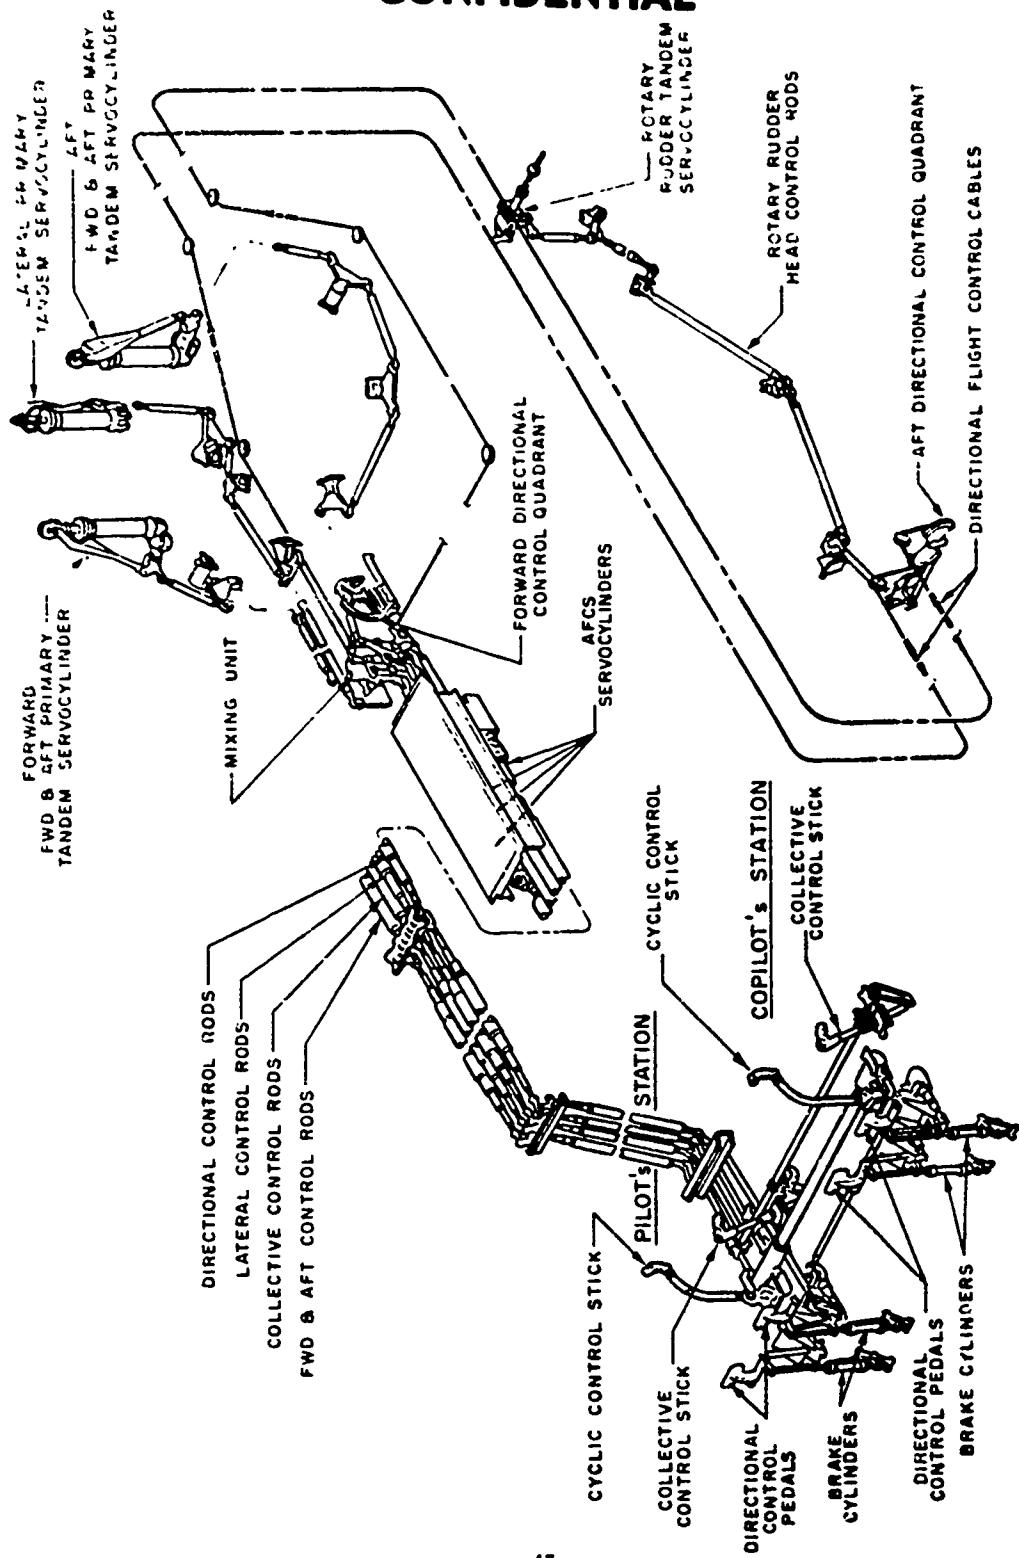
Figure 8. (U) Mechanical Control System (U)

The single hit occurring in Case 80003 resulted in non-critical damage when a caliber .30 bullet struck the bottom of the cockpit, travelled through the avionics platform, and expended against the torque tube connecting the cyclic sticks. The impact, occurring while the aircraft was 1600 feet above the ground, caused a 3/16-inch deep dent in the tube and stung the copilot's hand. The aircraft continued on its mission.

Three reports cited push-pull rod damage. Case 80015 involved a caliber .30 bullet creasing a section of the tail rotor control rod. The rod remained operational, but the mission was aborted for other reasons. In Case 80054 the aircraft was hit by several caliber .50 bullets while on approach. One round entered the forward compartment and caused "90 percent severance" of two control rods. Under partial loss of control, the aircraft was forced to continue the landing maneuver in an accelerated manner, landing with wheels up. FM antenna and fuselage skin damage was cited, but no further details were reported. In the third incident, Case 90027, two control rods were damaged by separate caliber .30 bullets while the aircraft was in a landing approach 60 feet above the ground. The landing was completed (a forced landing) successfully but no damage details were given.

Finally, in Cases 80105 and 90044 unspecified mechanical control components were hit. In the former, damage by one caliber .30 bullet caused the mission (sling load delivery) to be aborted. In the latter case, damage was caused by one of a total of 18 caliber .50 bullets hitting the aircraft. A forced landing resulted, with damage to several systems listed as causes.

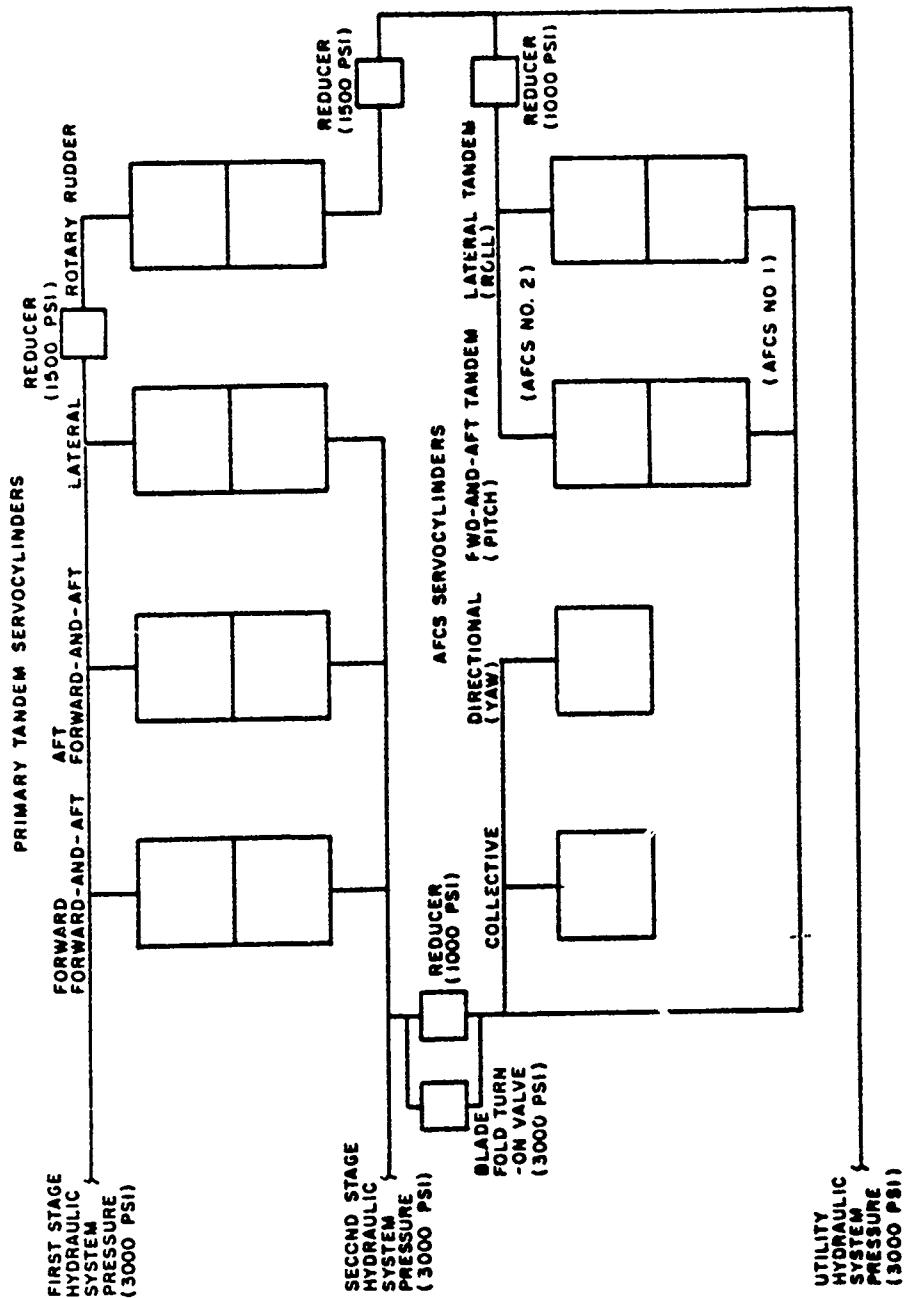
Figure 9. (U) Flight Control Hydraulic Systems (U)

Table E-IV presents a summary of reported hydraulic system hits. There were 18 such hits, and all but three produced leaks. Two incidents of hydraulic system damage each involved two hits on separate components; therefore, the total incidents of hydraulic system damage

5.7.1 First Stage Hydraulic System. The first stage hydraulic system was hit twice and both hits led to forced landings with the aircraft being recovered later. One hit severed a line and the other damaged an unspecified component.

The case involving a broken line on a CH-53A (Case 70237) resulted from secondary damage by a fragment generated when a nearby drive shaft coupling was struck by a caliber .30 bullet. Loss of pressure caused a precautionary forced landing.

In Case 80045, fragments from an AAA HE projectile struck a second stage servo and a line. Damage to the servo did not produce a leak, but the line was punctured and second stage hydraulic pressure was lost. The mission was aborted, but a safe return flight followed.

In Case 80081, one of 30 hits by caliber .30 bullets damaged an unspecified hydraulic system component(s), with subsequent loss of second stage servo pressure and fluctuating first stage servo pressure. The pilot was forced to land at a nearby friendly position, where emergency repairs were performed before a return flight was accomplished.

5.7.3 Utility Hydraulic System. The utility hydraulic system was damaged by ten hits in a total of nine incidents. A single mission abort was the only adverse reaction resulting from damage to this system. Utility hydraulic pressure was lost when damage occurred to the utility hydraulic reservoir and heat exchanger, and also lines serving ramp actuators, APP, cargo winch, and landing gear brakes; however, flight and mission were not affected by the damage. The mission abort came about when a caliber .30 bullet struck and penetrated the tail rotor tandem servocylinder; however, a safe return flight

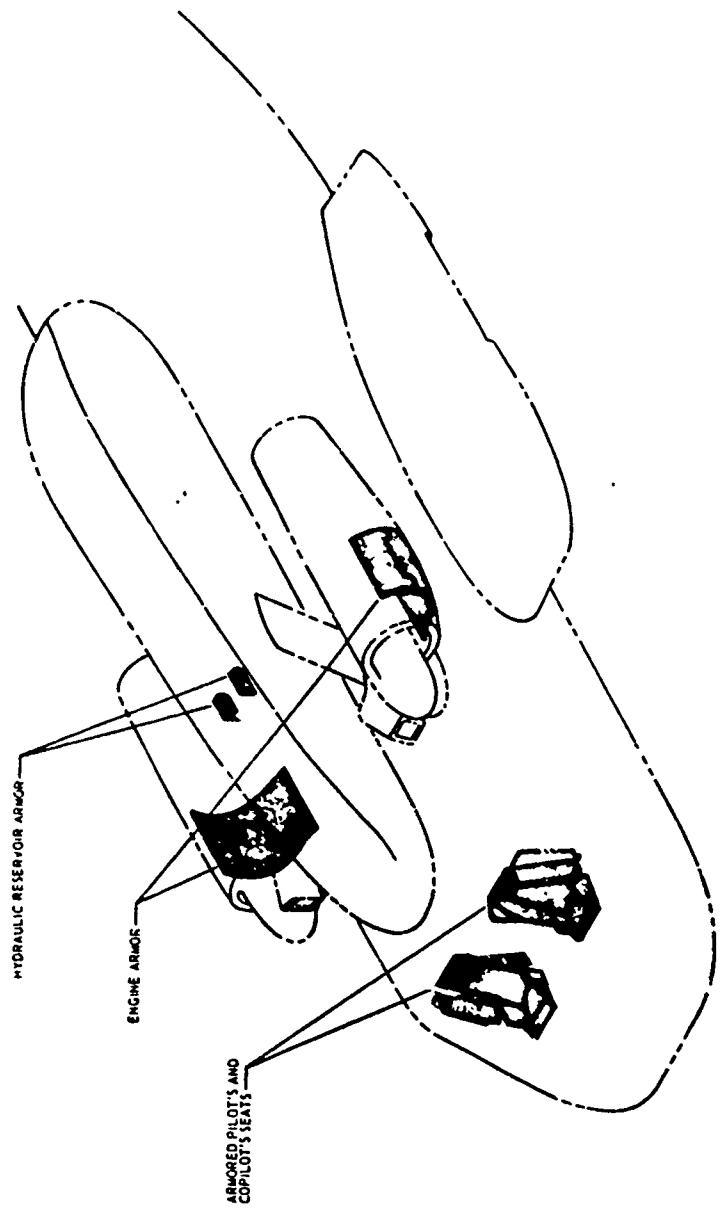
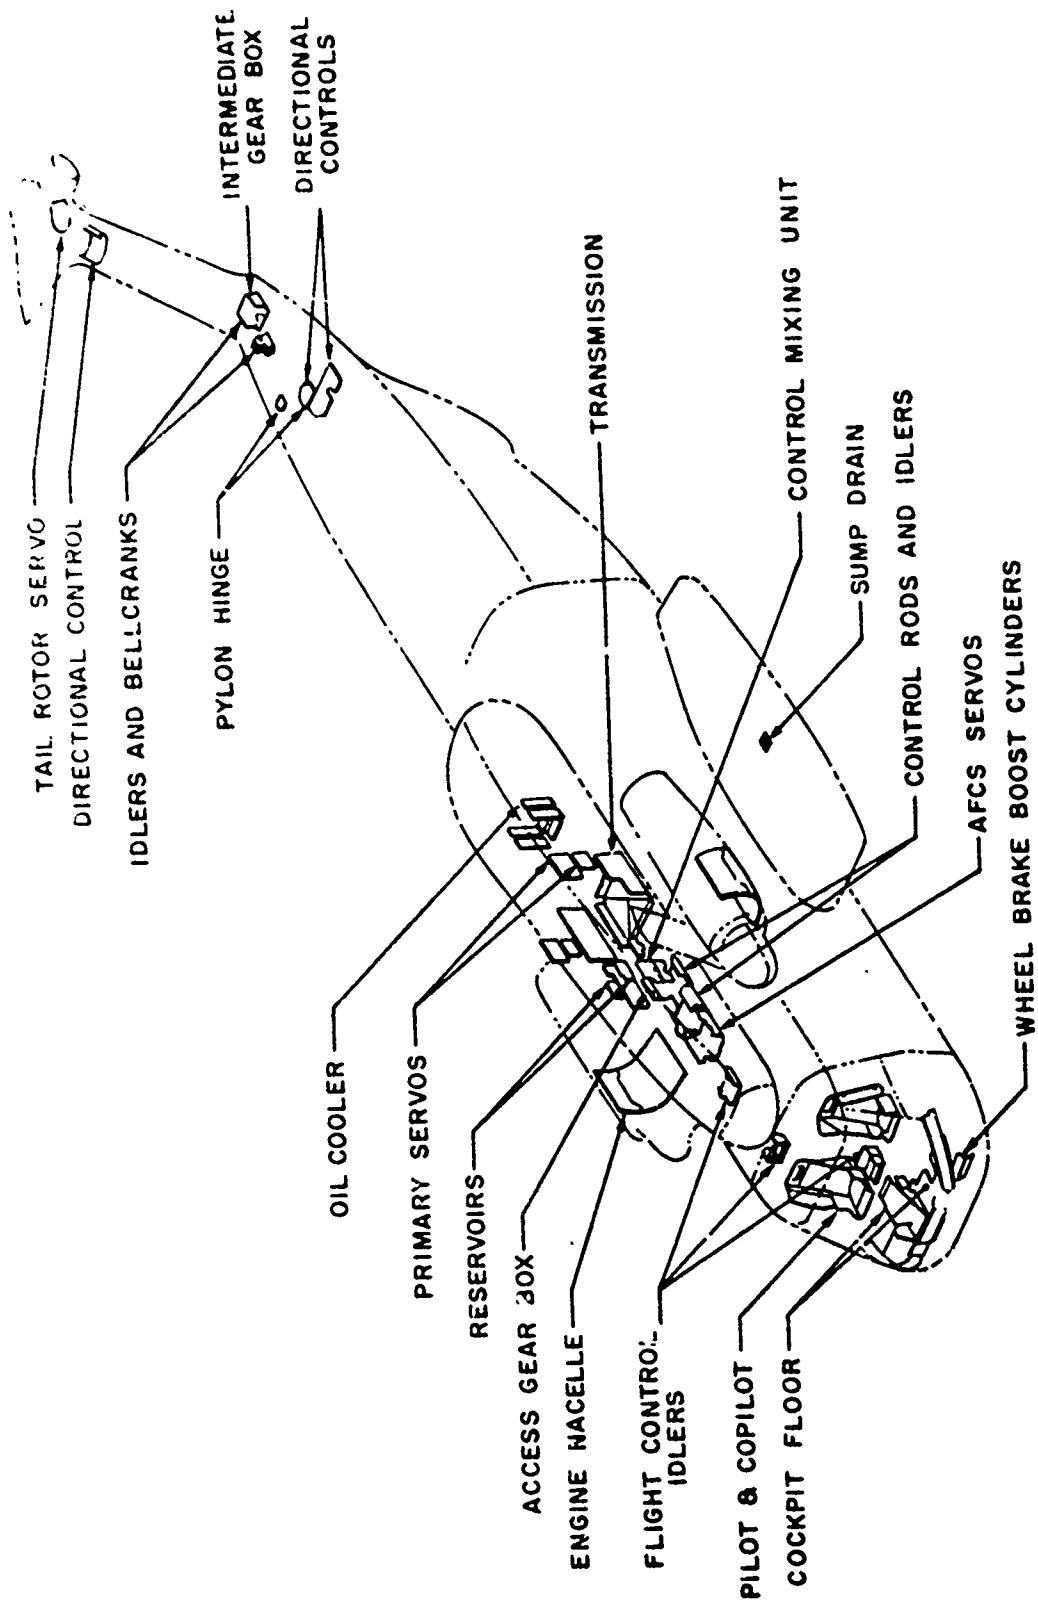
Reported hits on armor are presented in Table E-X. A total of eight reports specified 11 individual hits on armor. These hits break down to eight hits on engine armor, one hit on copilot's seat armor, one hit on hydraulic flight control servo armor, and one hit on an improvised flak "skirt" arrangement. Six of the eight cases involved CH-53A's, all of which involved hits on DPSA-2 engine armor. These installations successfully stopped caliber .30 bullets six times, including two caliber .30 hits on the same armor panel. A seventh hit, by a caliber .50 API bullet, caused an armor "failure," although the bullet failed to hit the engine. Coming from almost directly under the helicopter, the bullet struck the edge of the panel, perforated one of the mounting brackets, passed between the engine and the inner wall of the panel, exited through the top of the nacelle, and broke up against the rotor head.
